THE UNITED STATES
STRATEGIC BOMBING SURVEY

FIELD REPORT

Covering Air-Raid Protection
and Allied Subjects in

NAGASAKI, JAPAN

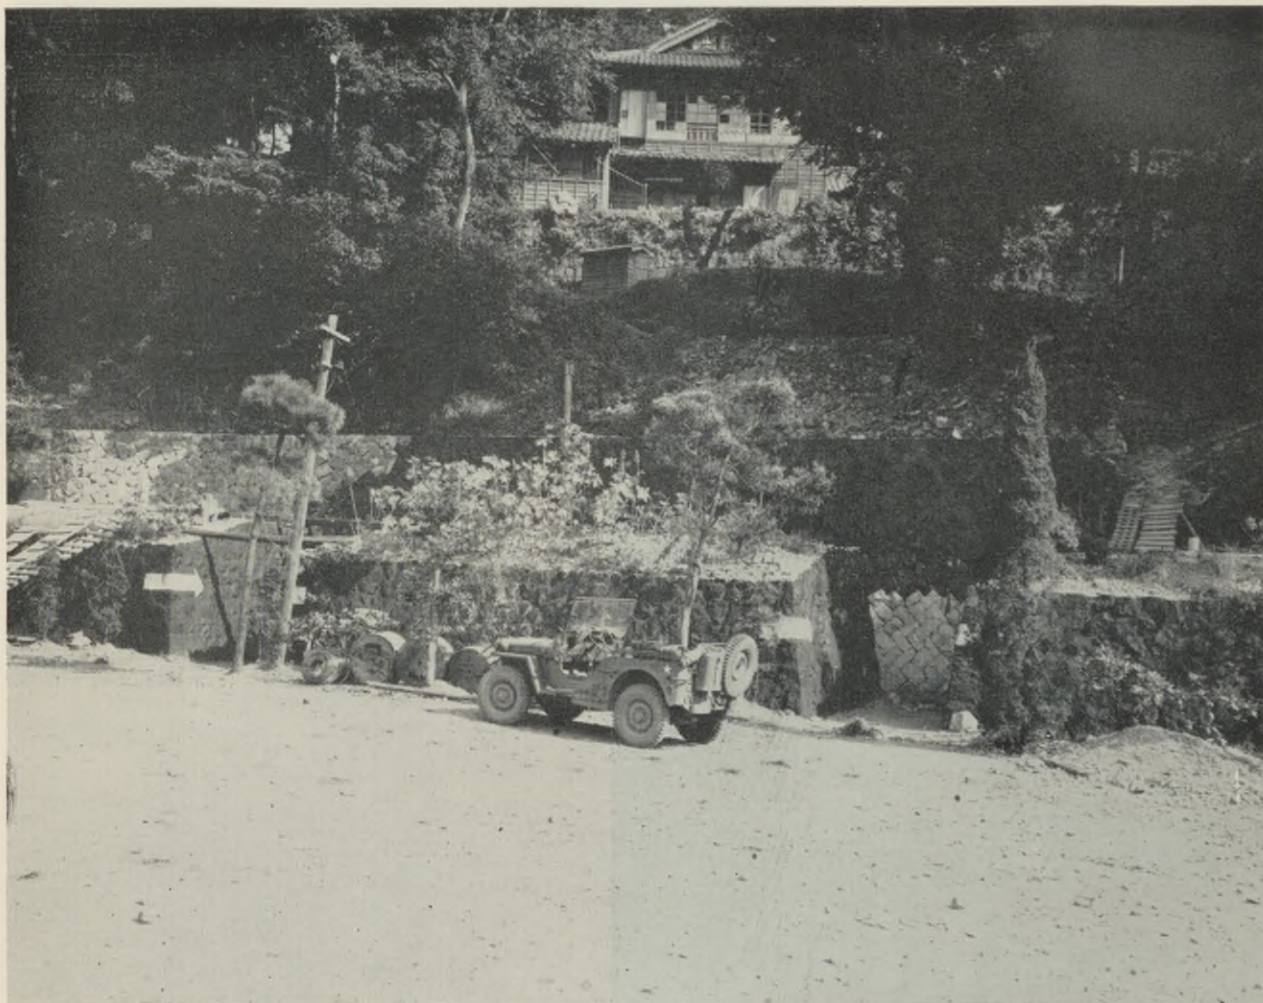
Photo 28. Concrete shelter built under the terraced mountainside. Built by the prefecture and used as the Nagasaki Prefecture air-defense headquarters and control center.

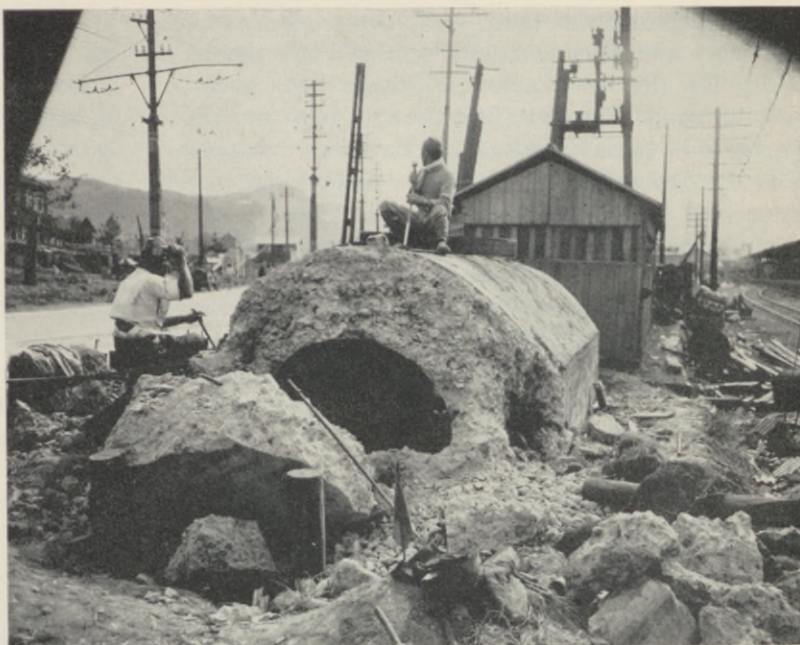
Photo 30. Concrete square shelter built for and by the navy personnel located at Nagasaki port. Concrete thickness at the base approximately 4 feet, tapered to 3 feet on top. Roof is of 2 feet by 2 feet planks, reinforced by approximately 1 foot of concrete and 4 feet of dirt at the thickest point.

(4) *Special Shelters.* The control center of Nagasaki was located in a shelter constructed along the specifications described in the preceding paragraph. (Photo 28.) As stated above and in previous reports, cement and steel were not available to the public after 1943, but it was observed that in many cases the military and industries engaged in war production were able to secure those materials to build shelters which would afford very good protection for their personnel. (Photos 29-30.)

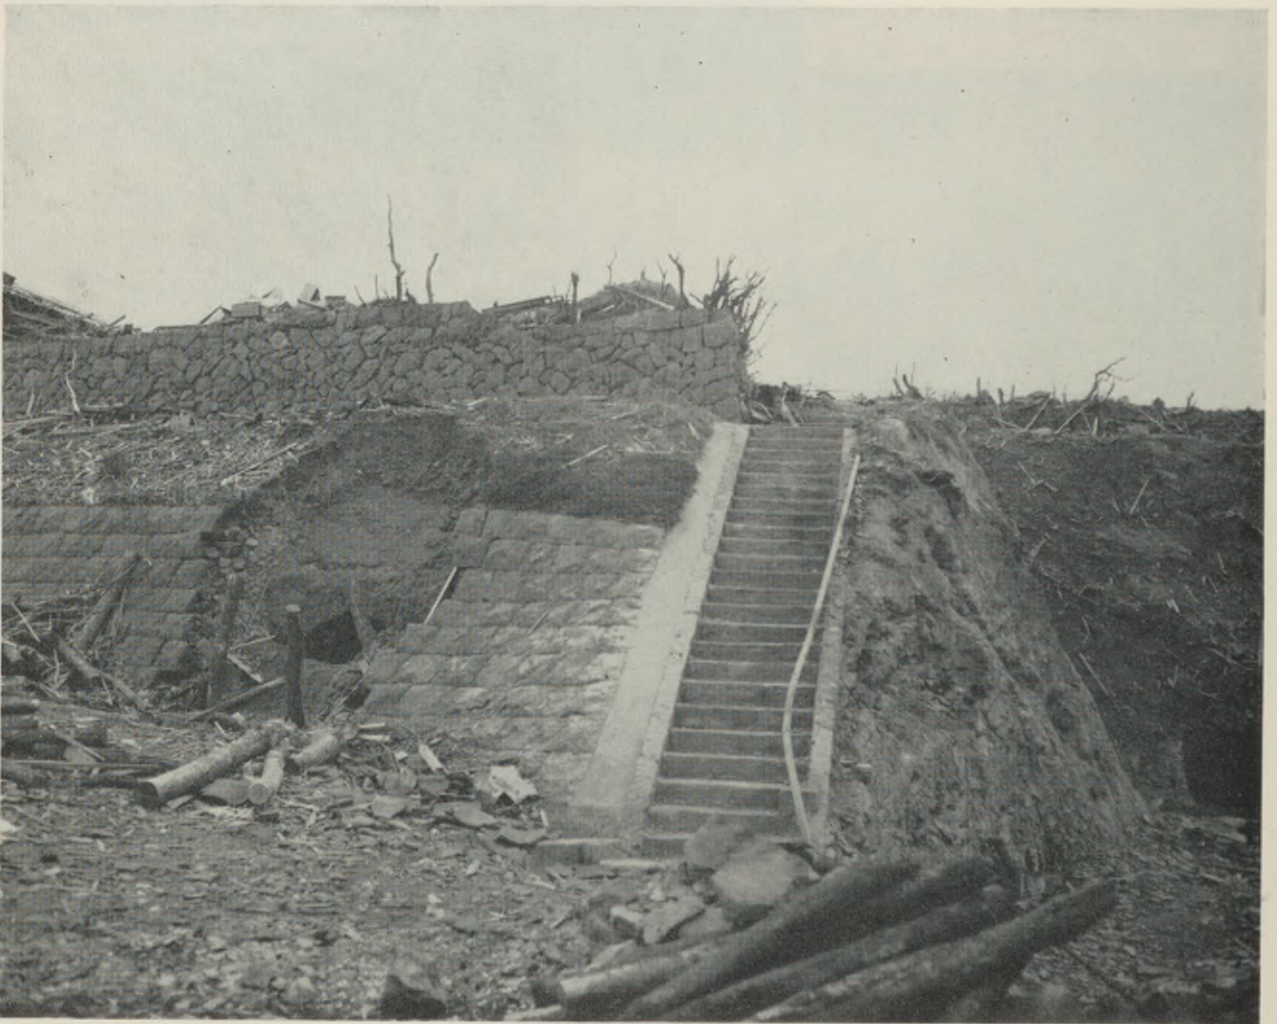
Photo 31. The dimensions and design of the shelter and the location of the persons at the time of the explosion are indicated on Figure 1. The approximate location of the subject is marked "A" and the locations of the others are marked with the symbols "x" and "o". Additional persons were outside the entrance.

a. Subject "A" and a number of other persons were working in a shelter located in the north side of an elevation, about 20 to 25 feet high, with the entrance approximately 200 yards from the estimated center of the bomb impact. The shelter did not have a baffle wall protecting the entrance, although material had been secured for that purpose. (Shelter 1, Exhibit *G*, and Photo

31.) Subject "A" was standing with her back toward the entrance when the explosion occurred. She was knocked over by the blast and was burned on the back of the legs and on the upper part of right arm. The scars remaining from the burns had the appearance of dark brown blotches which usually result from burns inflicted by hot

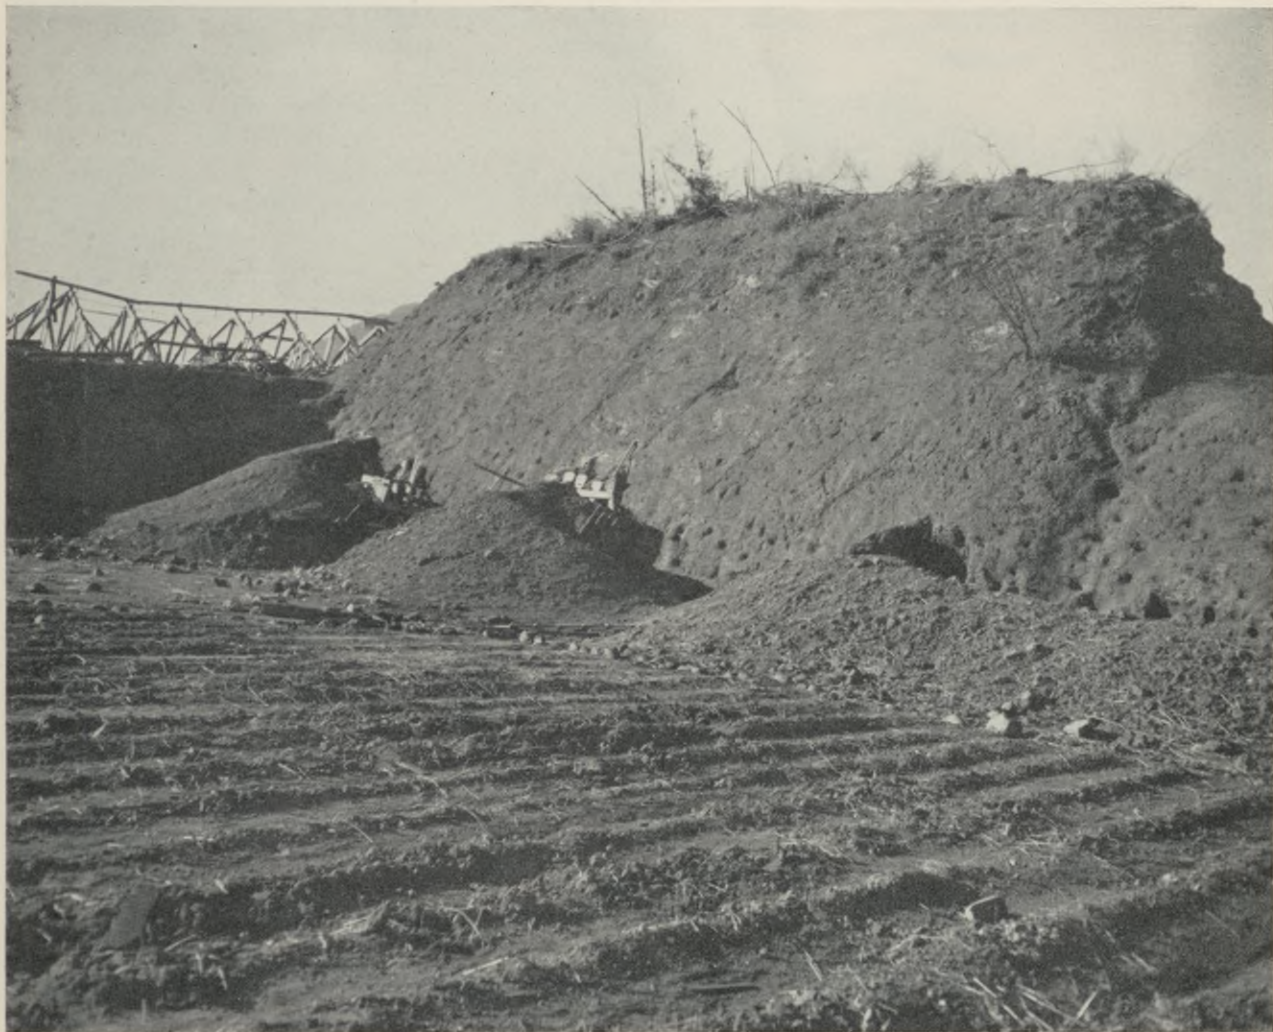
Photo 32. Shelter on which "B," "C," and "D" were working.

b. Subjects "B," "C," and "D," with about 20 other persons, were working on a shelter which was on an abrupt bank with an elevation of 50 to 60 feet (Photo 32) located about 600 yards directly west of the center of bomb impact. (Shelter 2, Exhibit G.) They were working in shifts with about eight persons inside the shelter and the rest outside at the time of the explosion. The type of shelter and locations of the subjects and the others in the shelter at the time of the explosion are indicated on figure 2.

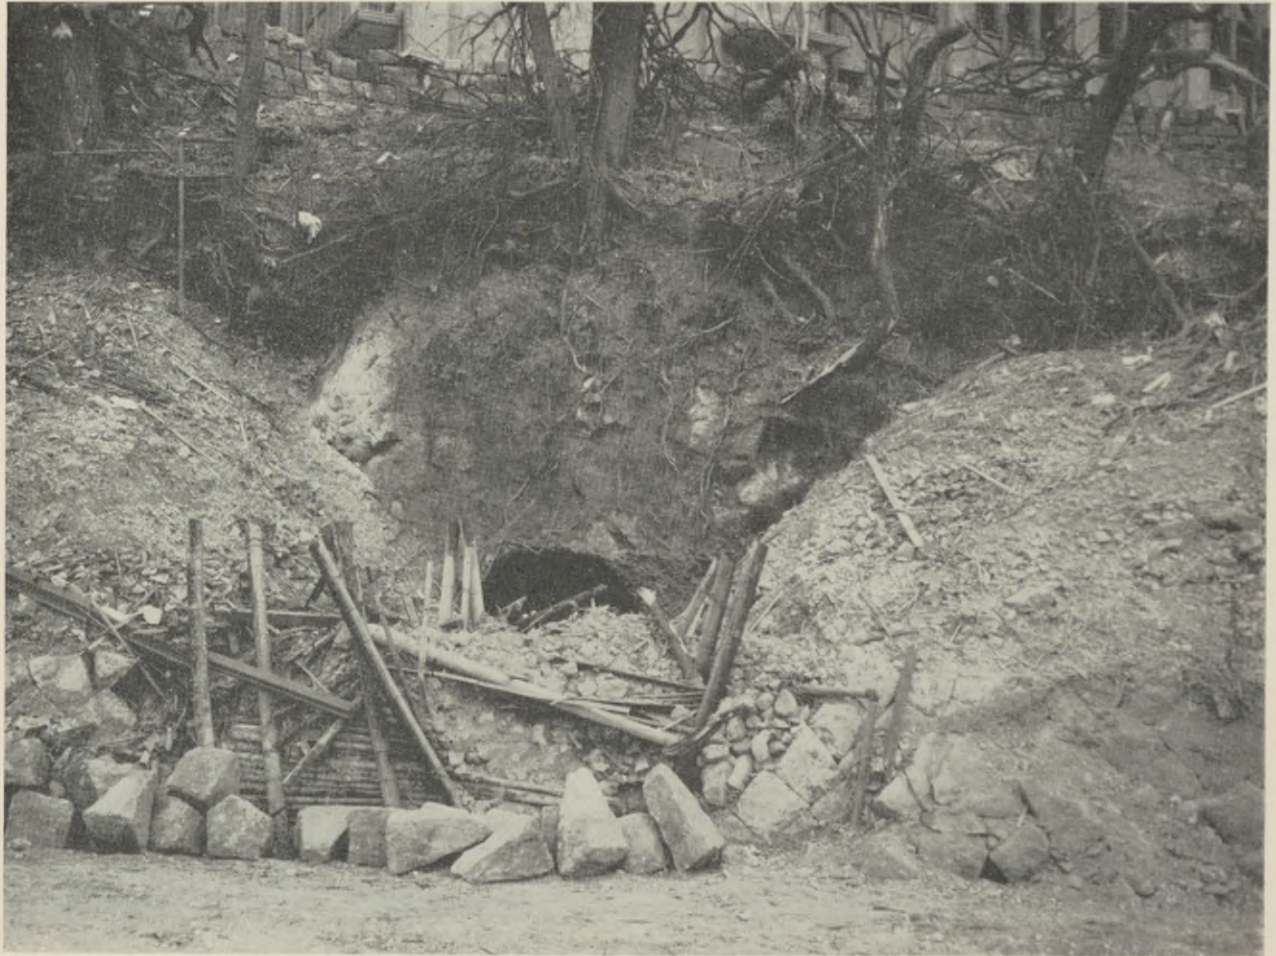
Photo 34. The shelter and location of individuals are indicated in figure 4.

d. *Subject "F"*. This individual was an engineer employed by the city of Nagasaki to supervise the construction of tunnel shelters. He was not in a shelter at the time of the explosion but was at the shelter on the afternoon of the day of the explosion. (Shelter 4, Exhibit G, and Photo 34.) There were about 15 persons (indicated by "X's") standing in the entrances, who were killed as a result of the blast and the driving of the baffle wall into the shelter entrance. About 20 persons (indicated by "O's") who were in the part of the tunnel connecting the two entrances were only slightly burned and injured, and have recovered without any apparent ill effects. This shelter was about 800 yards from the center of impact.

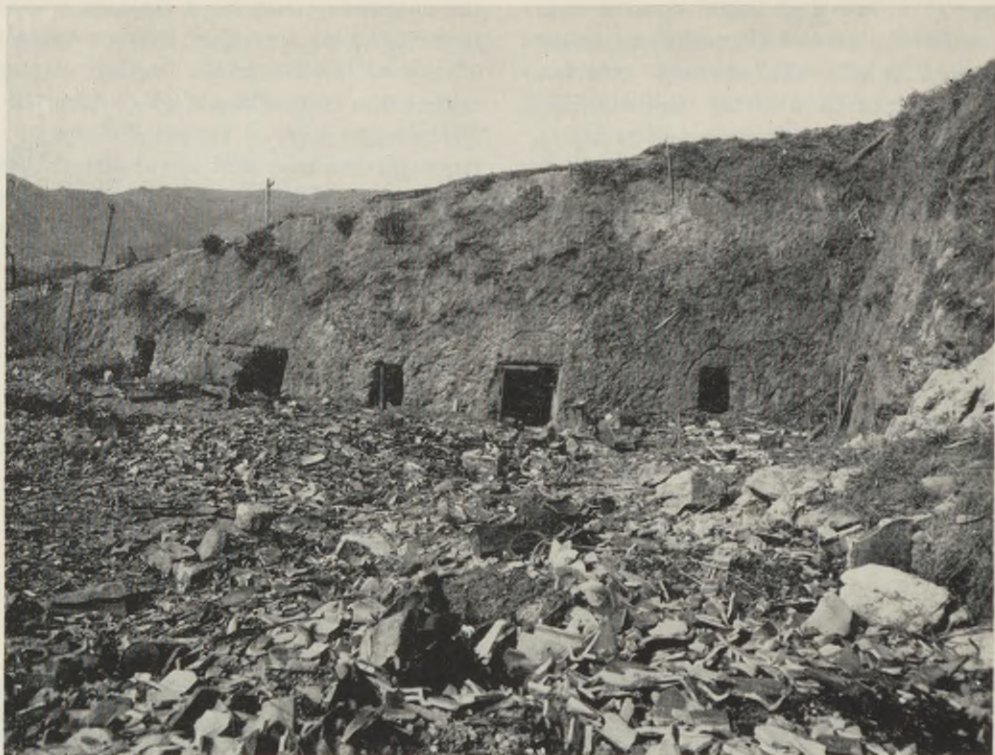
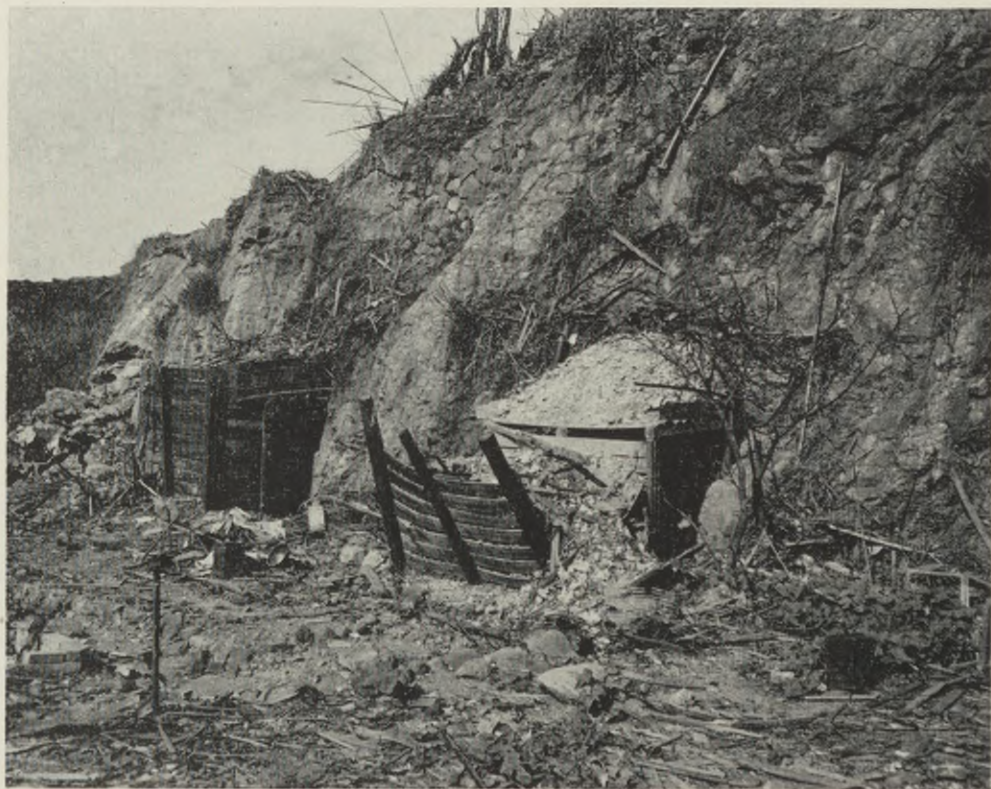
Photo 35.

Photo 36. Pictures showing conditions of tunnel shelter entrances located 35 to 50 yards from the center of impact of the atomic bomb.

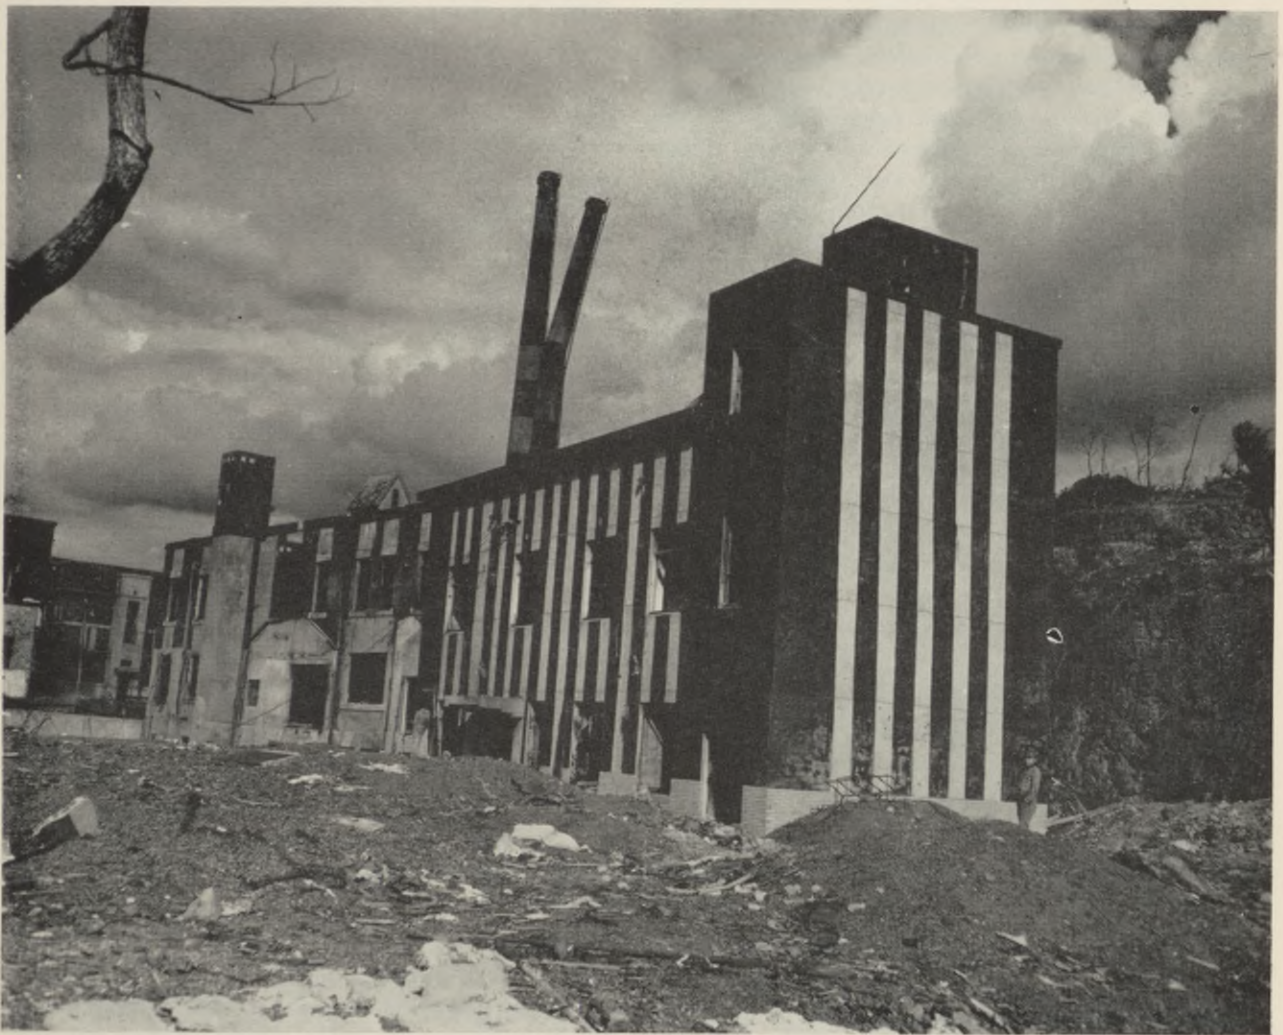
Photo 39. Photograph of one of the wings of the University hospital at Nagasaki, showing method of camouflage by applying black paint over portions of the yellow stucco finish. It was hoped to achieve an appearance of grayness at a distance to blend the building into the dark hills in the background.

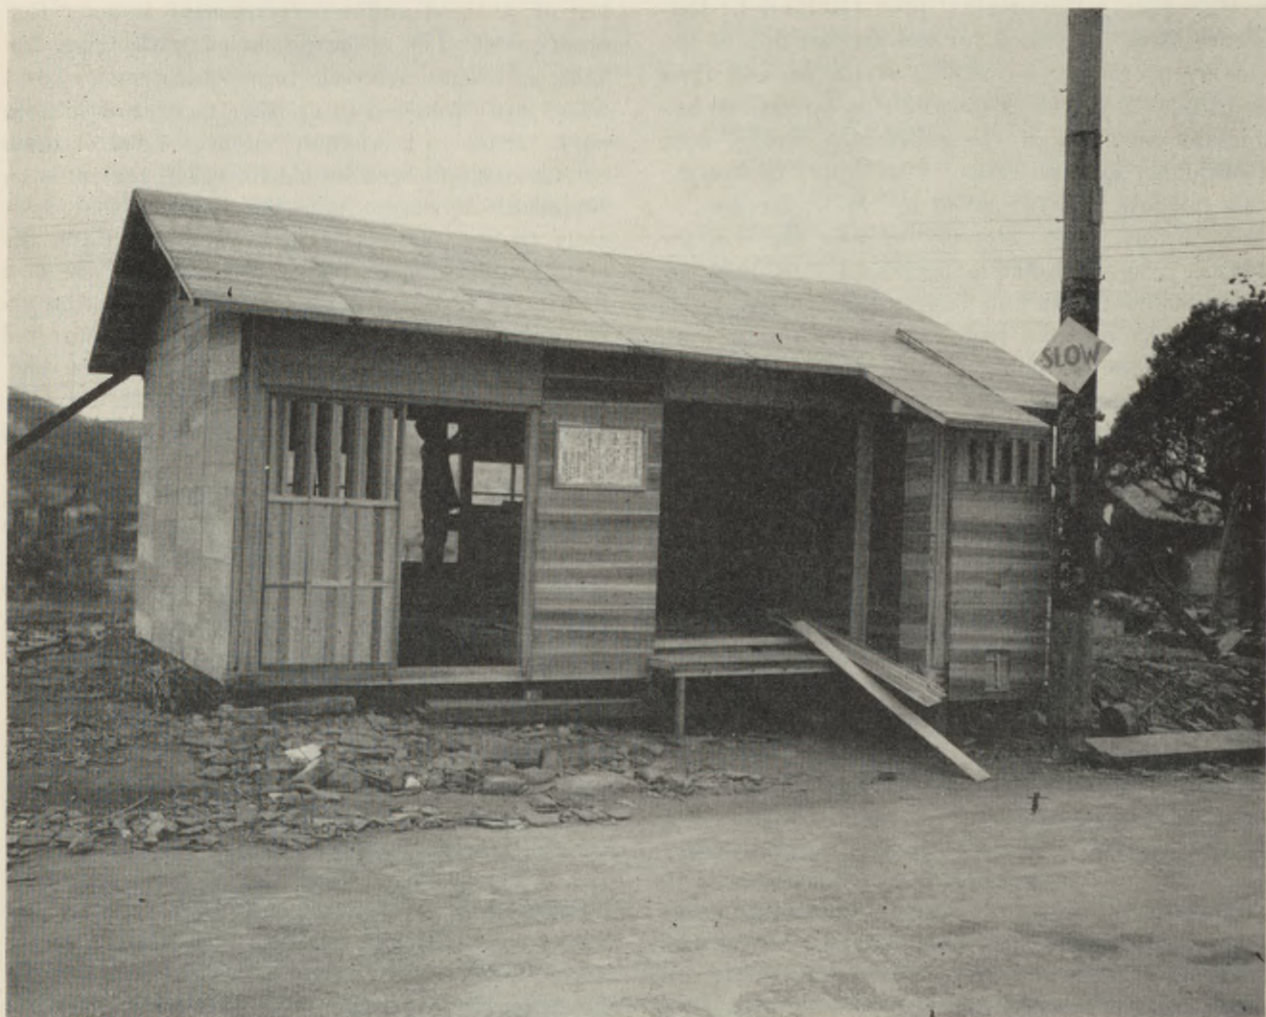
Photo 40. Sample house constructed under the auspices of the building construction corporation at Nagasaki. Estimated cost, 2,500 yen.
